NASA CR-120980  
BAC Report No. 8654-953003

# FINAL REPORT APPENDIX

## NONDESTRUCTIVE TESTS OF REGENERATIVE CHAMBERS

**FINAL REPORT - APPENDIX**  
**NONDESTRUCTIVE TESTS OF REGENERATIVE CHAMBERS**

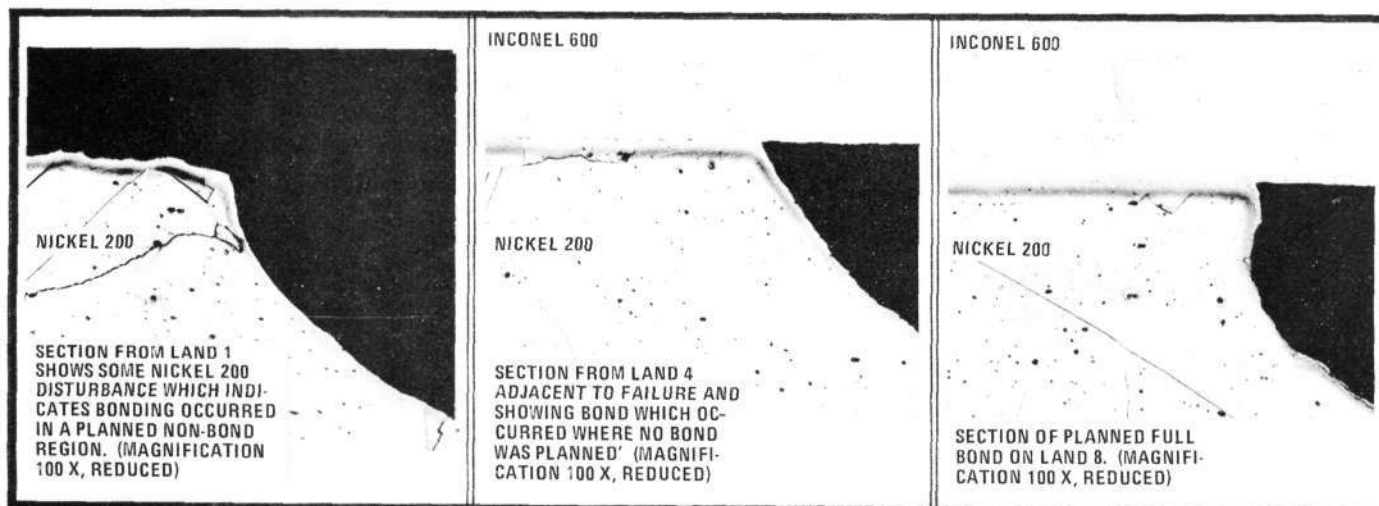
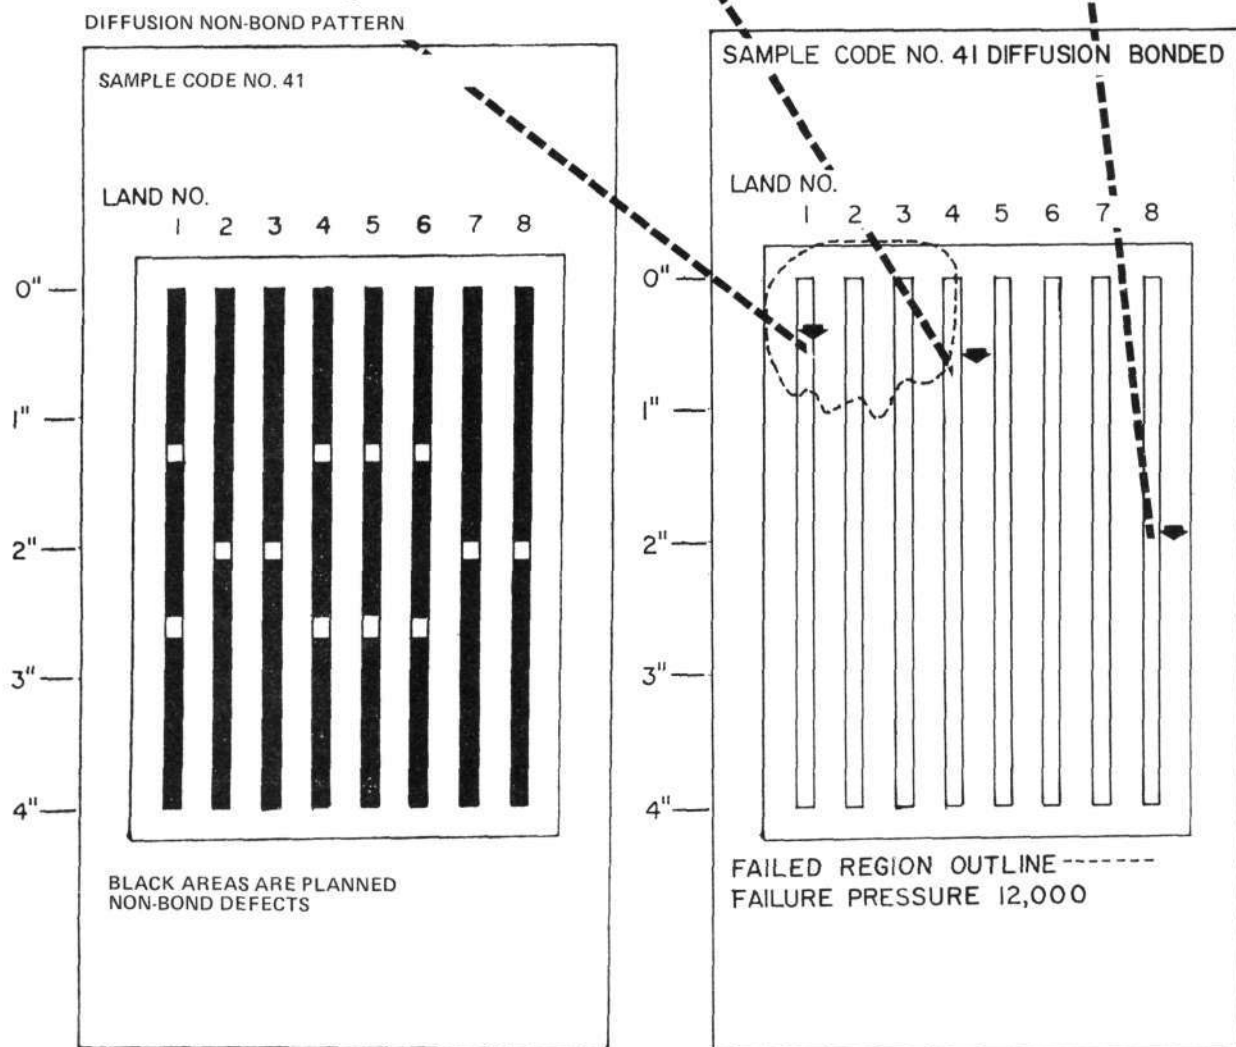
FIGURE A-42

TEST RESULTS ON DIFFUSION NON-BOND PANEL NO. 41

TEST PRESSURE 1400 PSI

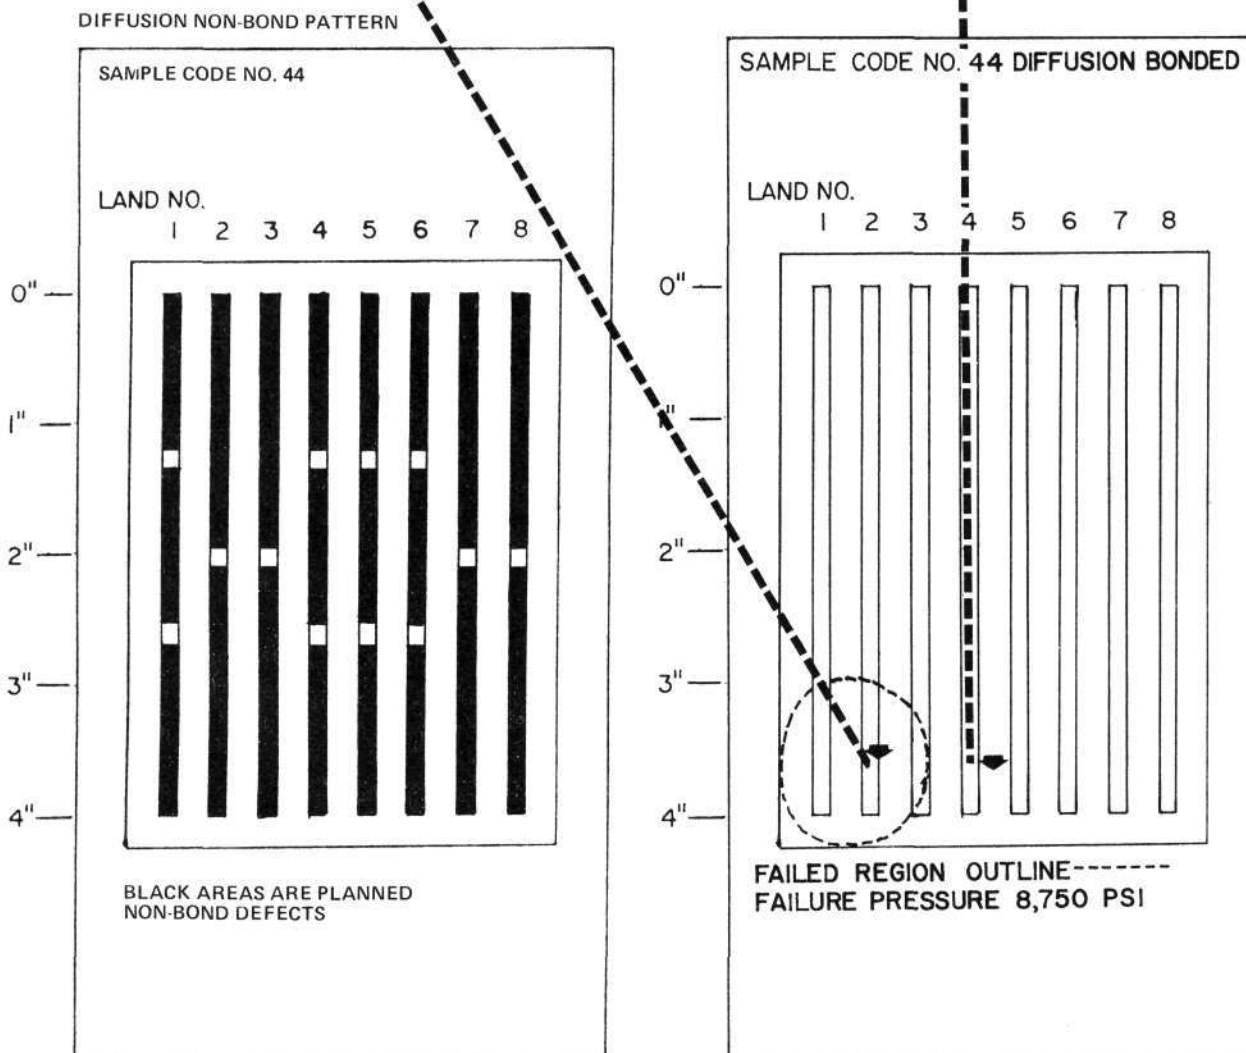
FIGURE A-44

TEST RESULTS ON DIFFUSION NON-BOND PANEL NO. 44

TEST PRESSURE 1400 PSI

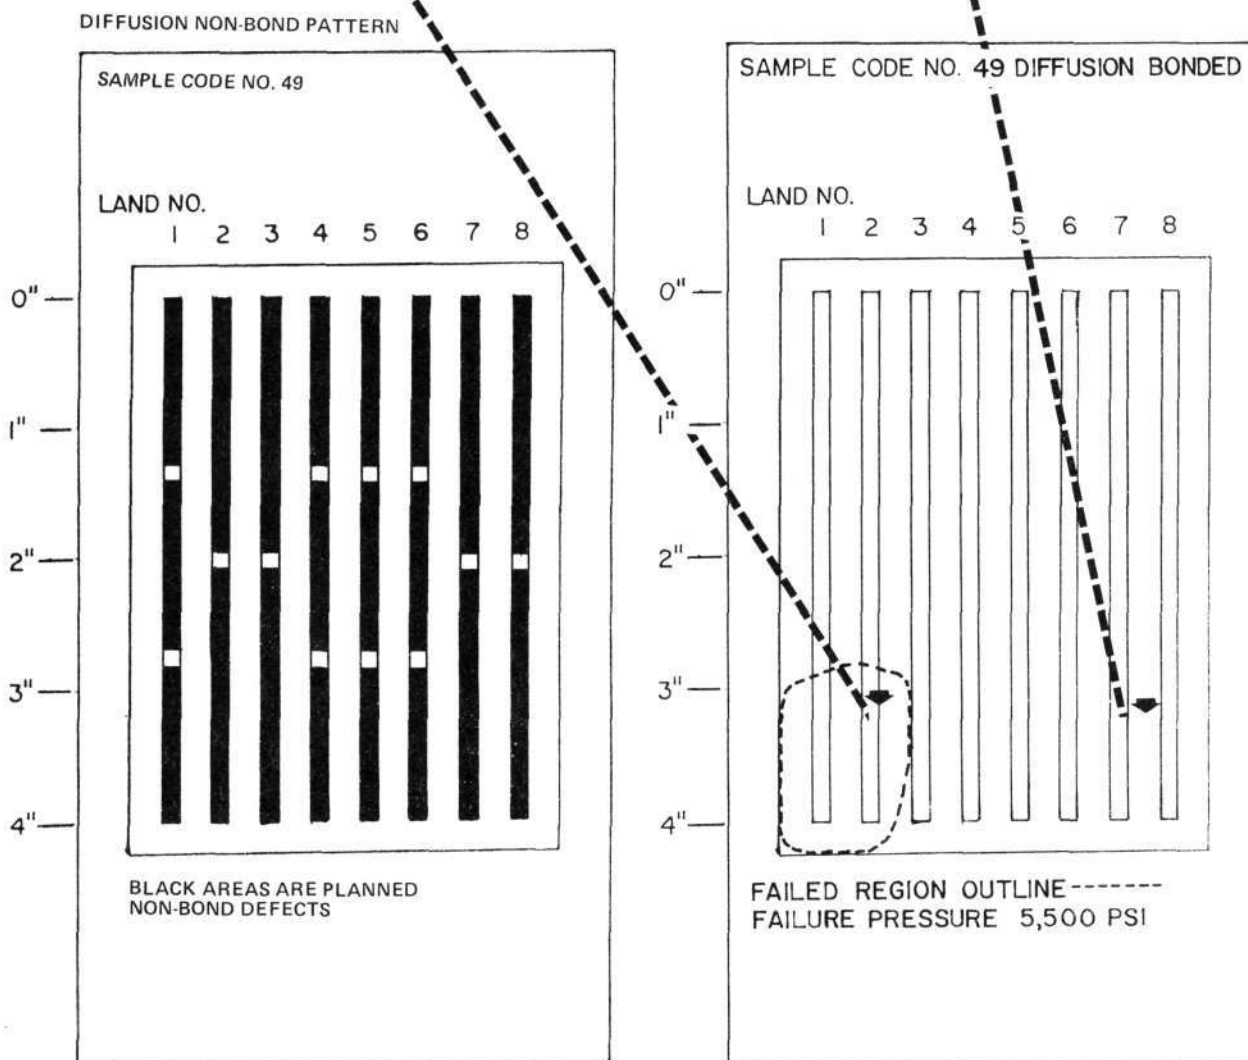
FIGURE A-45

TEST RESULTS ON DIFFUSION NON-BOND PANEL NO. 49

TEST PRESSURE 1400 PSI
